## CHAPTER 2 - FLOOD PROOFING PERFORMANCE

This chapter presents in narrative form information on how flood proofing measures performed when tested by flooding. The information presented was gathered by an experienced engineer who viewed the structures and the flood proofing measures after they were subjected to floodwater. The structures are numbered in accordance with the numbering system used in Tables 1 and 2 of Chapter 3. A short discussion of the flood event precedes each respective group of structures. Photographs of individual structures or flood proofing measures are shown if they were available and if they were considered to be of value in understanding why the flood proofing measure either was successful or failed.

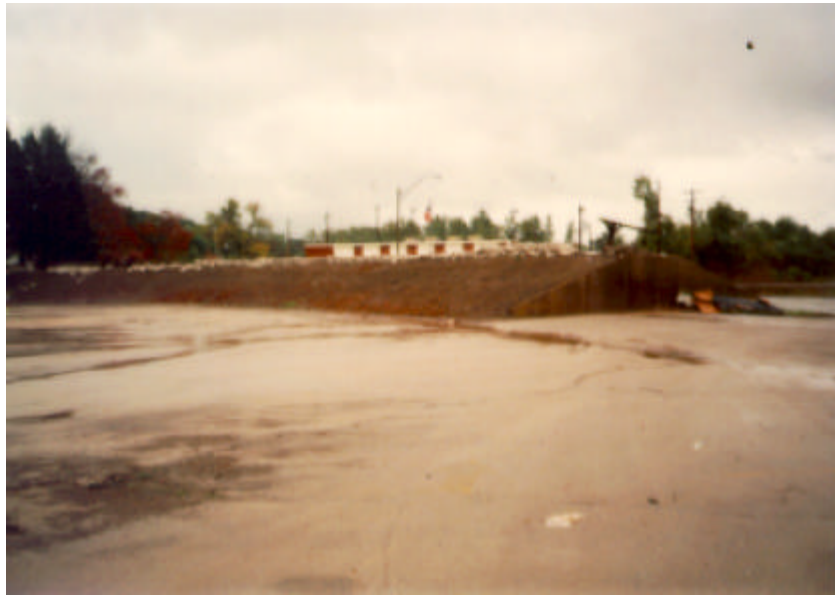
Looking at the portion of the partial ring levee with flatter sideslopes. Note the opening that was closed with a closure structure that was successful. Note the sandbag flood fight on top of the levee.

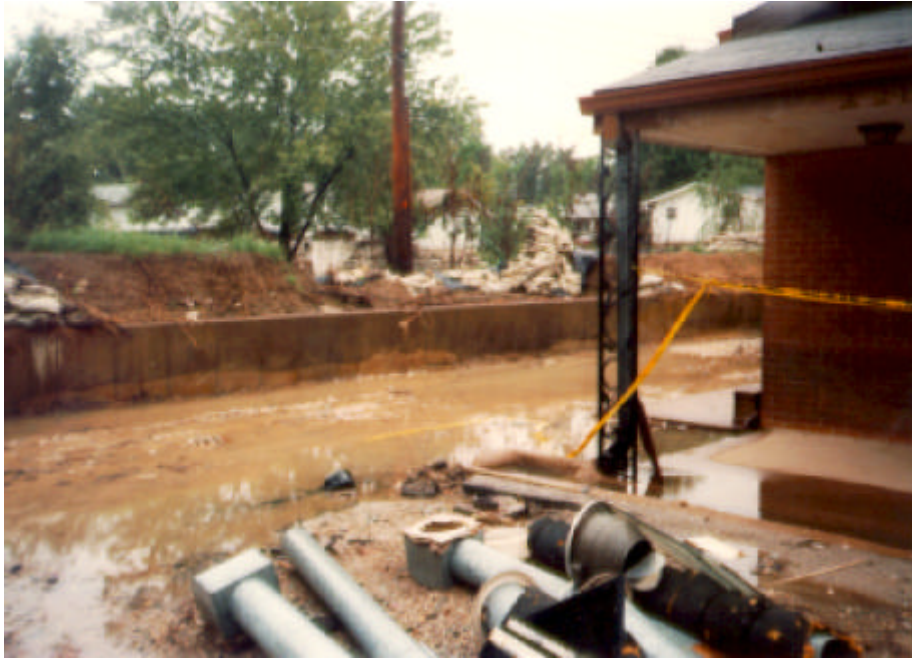
**Lesson.** In this case, all parts of the flood proofing system functioned as intended except that the levee was overtopped, leading to levee breaching. Obviously, the levee should have been higher for this event. The levee failed where the sideslopes were 1 vertical to 1 horizontal. Levee breaching may not have occurred if flatter sideslopes (1 vertical to 3 horizontal or flatter) had been used. Sideslopes of 1 vertical to 1 horizontal are without question too steep for reliable levee stability. Without levee breaching, a successful flood fight may have been possible. This flood proofing system had a definite weak point -- that portion of the levee with the 1 vertical to 1 horizontal sideslopes. If not enough area was present for a levee with flatter sideslopes, a floodwall should have been built in that location.

Looking at the portion of the partial ring levee with steep sideslopes that resulted in complete failure due to breaching.

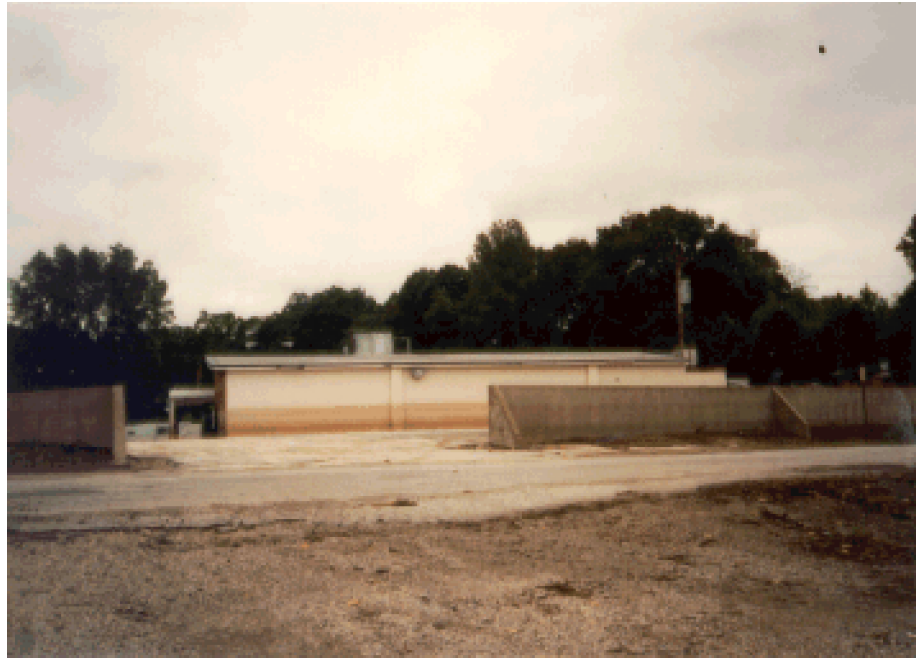
**STRUCTURE 44.** This site was about 300 feet from a backwater area connected to the Mississippi River. Flood duration and warning time were several days. The flood proofing system at this location consisted of a floodwall tied to high ground at each end. The system protected several mobile homes, a laundromat, and a store. At the highest point, the floodwall was 6 feet high. It was supported at intervals by means of concrete braces located on the “wet” side of the floodwall. The floodwall was overtopped by 3 feet, the mobile homes were destroyed, and the two permanent buildings were severely damaged.

Looking at the floodwall and also the building on the “protected” side. Note the bracing on the “wet” side of the floodwall.

**Lesson.** This system apparently worked well until it was overtopped. Floodwall bracing, if placed on the “dry” side of the wall, would provide more reliable support in a compression rather than tension mode. In regard to the wall being overtopped, a 9-foot-high wall (to eliminate overtopping in this event) probably would have been more expensive than relocating the mobile homes and two permanent buildings. Relocation out of flood-prone areas is the ultimate in flood proofing. Conducting a flood fight by raising the wall with temporary “flashboards” made of supported plywood may have been possible, although a 3-foot extension on a 6-foot wall would probably have reached the upper limits of reliability.

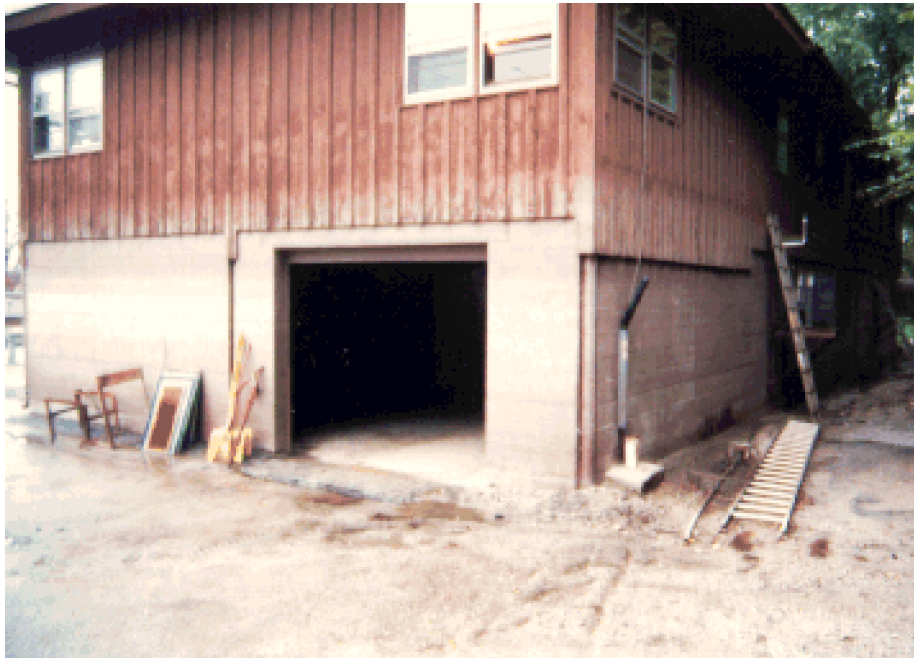
Looking at a typical structure elevated on extended foundation walls. Flood depth was about one foot above the main (elevated) floor. Note the elevated utilities on the outside wall.

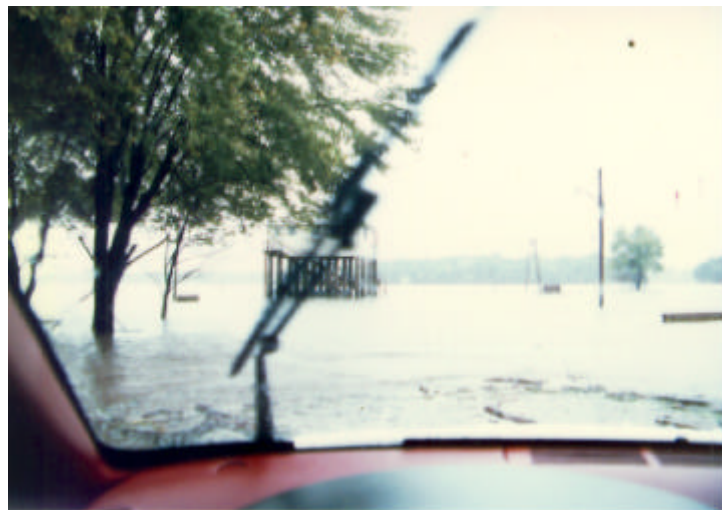
Looking at a typical structure elevated on masonry columns with bracing. The structure is nontypical because it was the only elevated structure viewed that was above the flood.

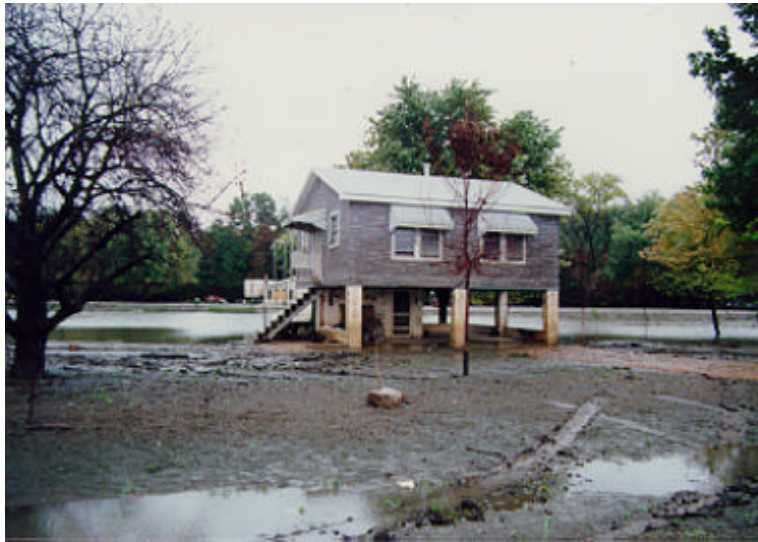
Looking at a typical structure elevated on masonry columns that had water above the main (elevated) floor.

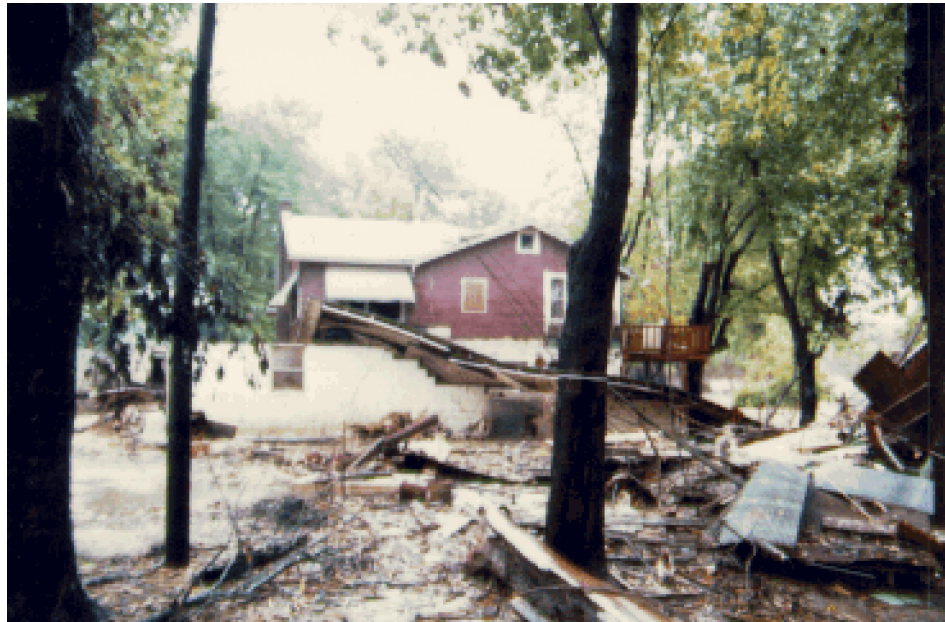
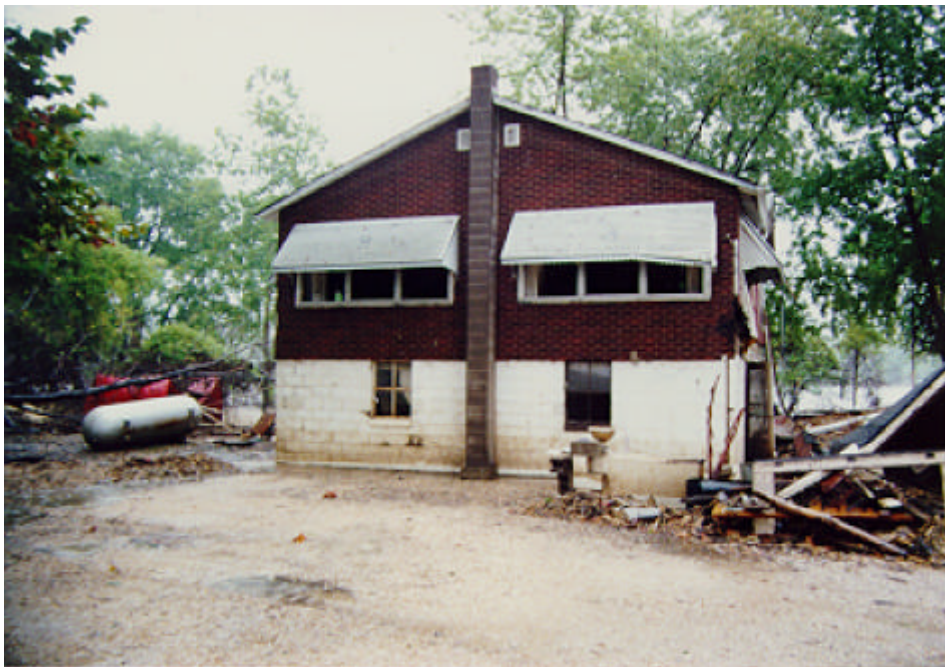
Looking at Structures 52 and 53.

**Lesson.** In each of the four cases, the flood proofing system provided sufficient elevation for the first floor. The problem was the extended foundation walls that were constructed of concrete block completely enclosing the lower area with the exception of doors and windows. This enclosure created an obstruction to the high-velocity floodwater, thereby subjecting the walls to large hydrodynamic force. Two of the structures totally collapsed due to complete failure of the extended wall support system. No steel reinforcement or grouting in the walls was apparent. The other two structures were standing, but one side of the extended concrete block wall supporting the first floor collapsed on each structure. Examination of the collapsed walls on these two structures showed some vertical reinforcement of the wall with rebar and grout. No lateral reinforcement was observed. In all

four structures, the extended concrete block wall to support the structure should not have been used in an area close to a major river where high velocity during floodflows could occur. Supports such as columns, posts, or piles embedded sufficiently below grade should have been used, with piles being the preferred choice. Any enclosure of the lower area should have been of minimal strength to easily break under hydodynamic force.

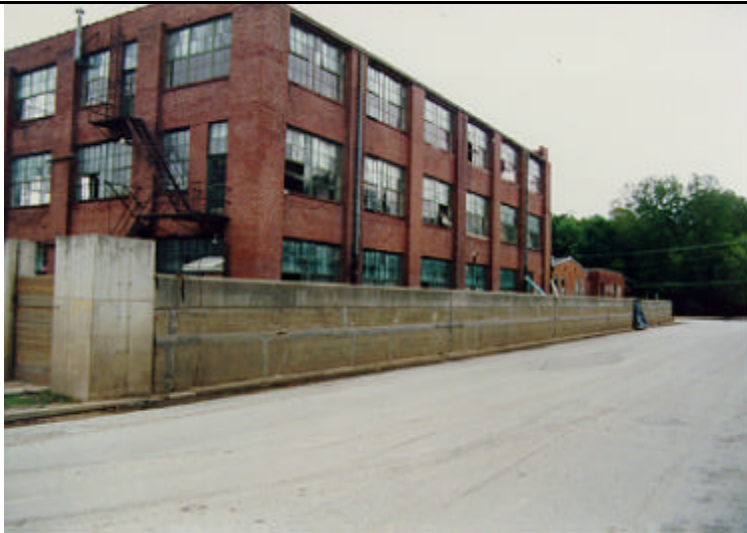
**Lesson.** About 150 feet of the wall collapsed at the seam between the original wall and the first 2-foot extension. Of the 150-foot section that failed, a 90-foot section had foundation failure. Both failures occurred because (1) the original wall footing was not designed for extensions doubling the original wall height and (2) the assumption that rebar tied the first extension to the original wall was false. Upon wall failure and due in part to the close proximity of the wall to the building, the building roof subsequently failed. After the flood, the building was being abandoned and the industry was relocating to a flood-free site.

Looking at the floodwall. Note the closures at left and far right, the original floodwall, and the two additions. The failed portion is between the building and the trees in the background.

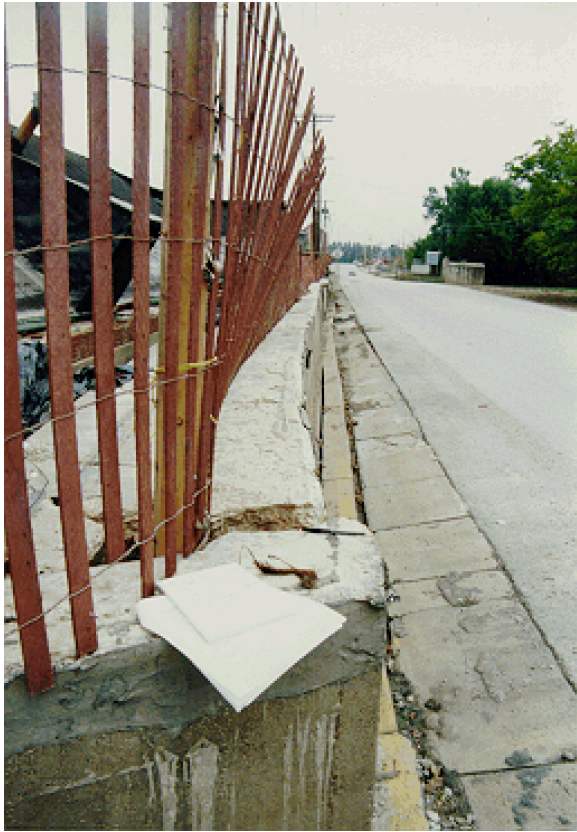
Looking at the original floodwall. Note the foundation failure resulting in wall misalignment. Also, note the absence of rebars on the original floodwall.

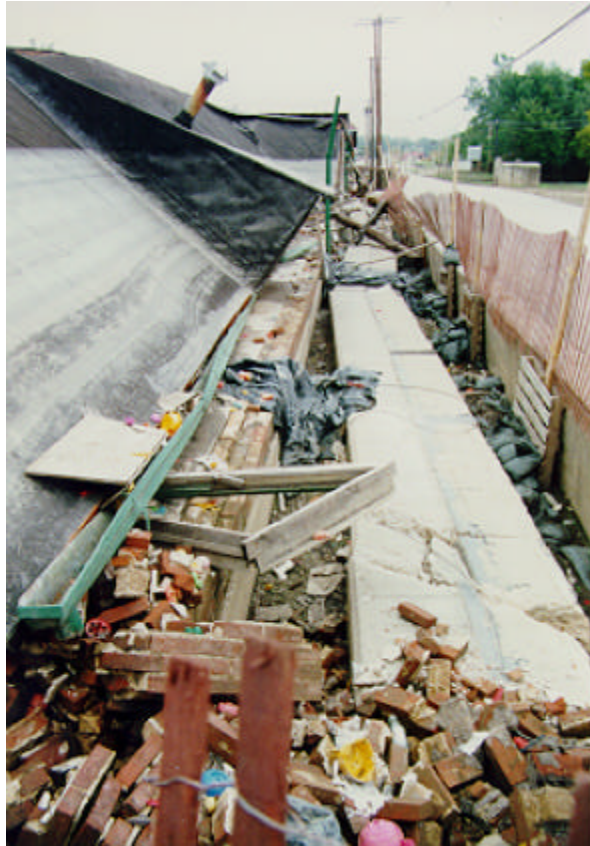
Looking at the collapsed floodwall additions. Note these two additions are still tied together with rebar.
